ENVIRONMENTALLY SENSITIVE EQUIPMENT FACILITIES
IN THE
CIA HEADQUARTERS BUILDING
LANGLEY, VIRGINIA

Real Estate and Construction Division
Office of Logistics

5 March 1973

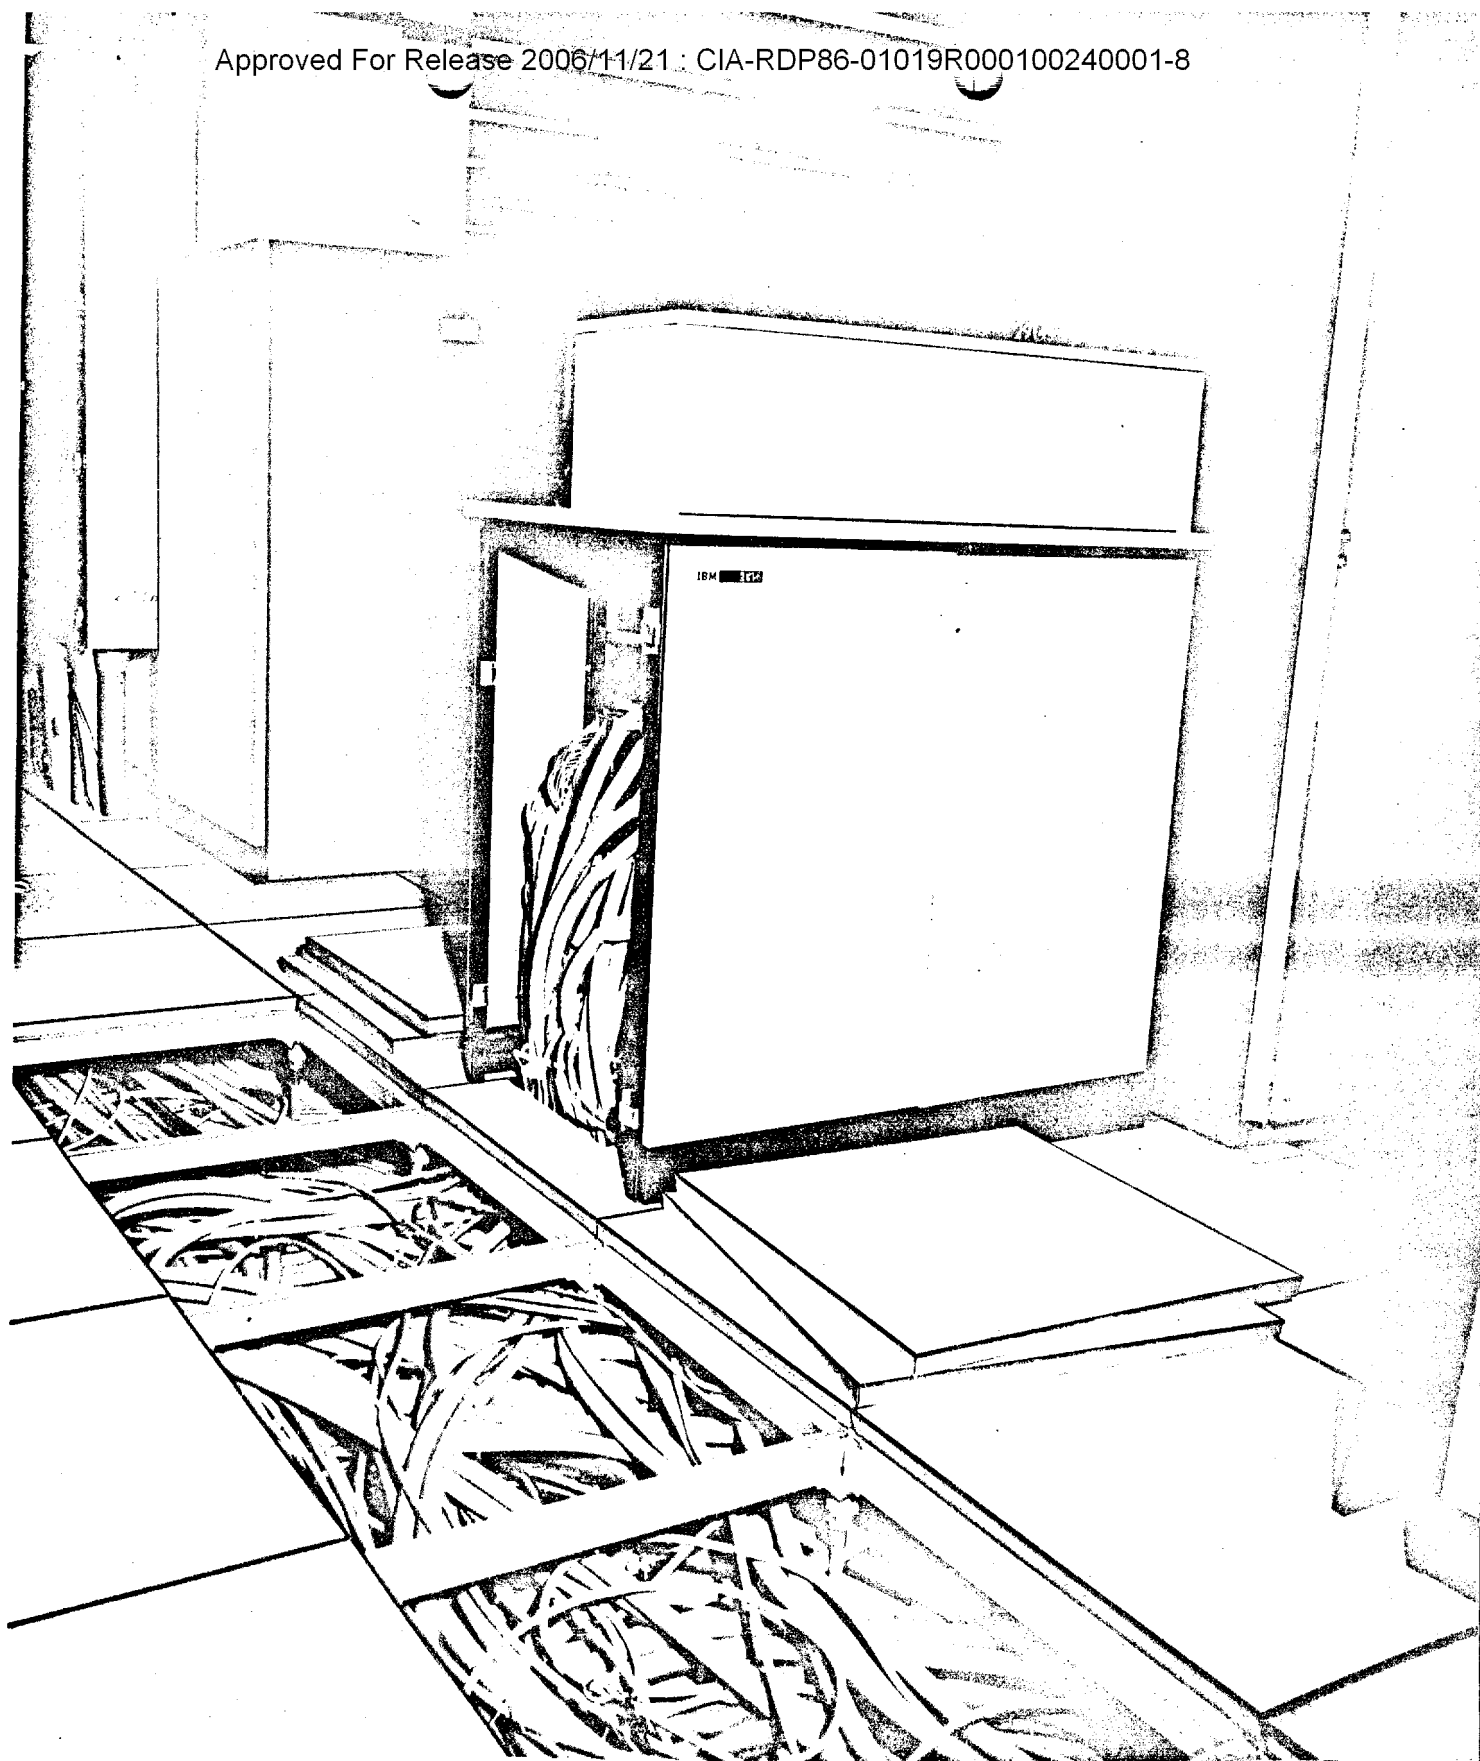
fig. 6.

View 3 - Underfloor Conditions OCS Area GC03
